Extreme Weather Vulnerability Assessment

Village of Lancaster, NY

December 2020

C&S
COMPANIES®

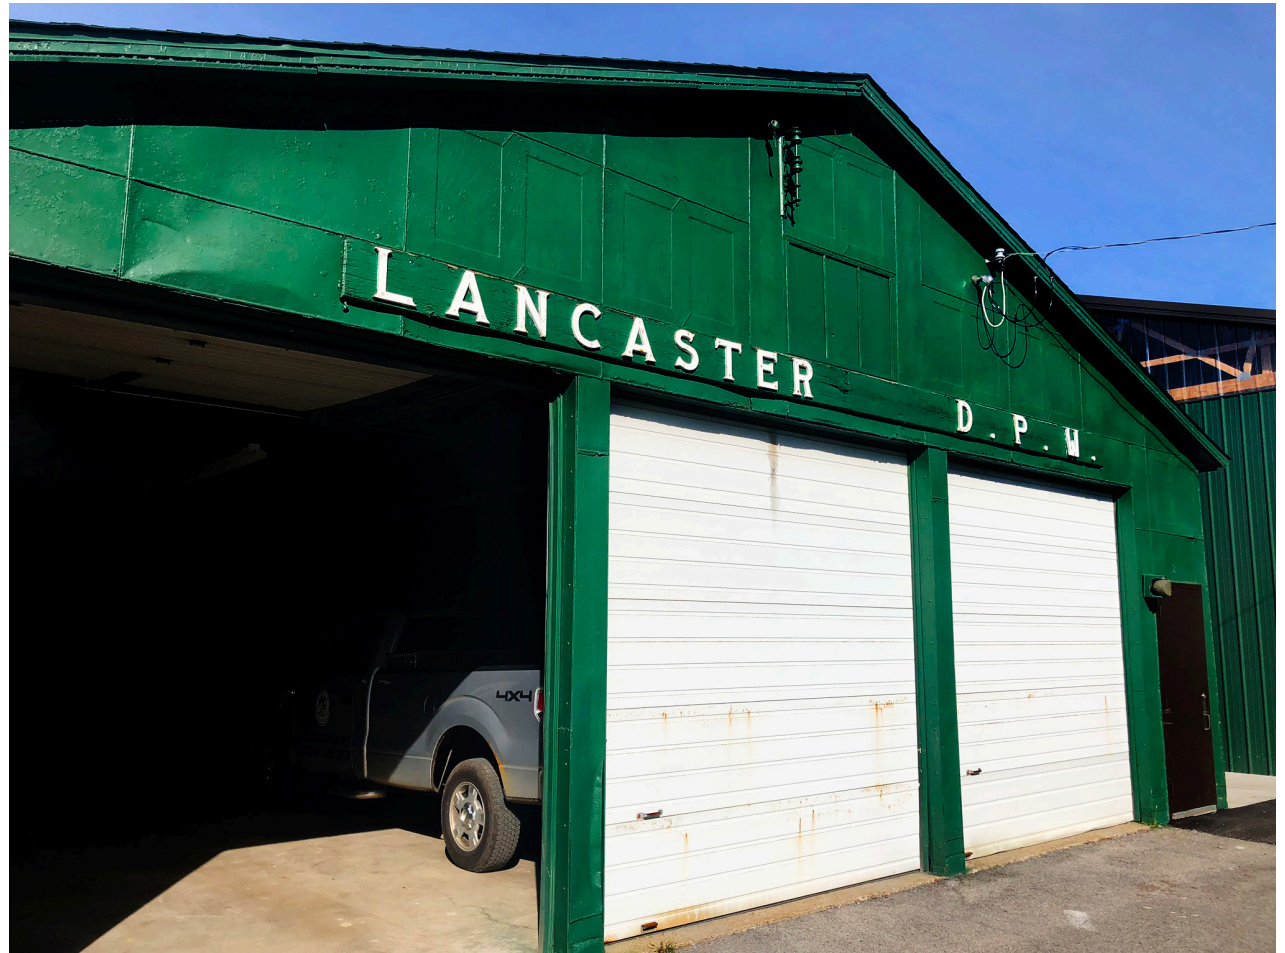
- ◆ **Salt Barn**—The Salt Barn was constructed in 2008. Original building drawings were available. The majority of the high bay roof framing could be viewed from below and appeared in fair condition. The roofing was not accessible, but appeared to be in fair condition from a distanced view.

- ◆ **Pole Barn**—The Pole Barn was constructed in 2019. Original building drawings were not available. The majority of the high bay roof framing could be viewed from below and appeared in good condition. The roofing was not accessible, but appeared to be in good condition from a distance view.
- ◆ **Old Metal Barn**—The Old Metal Barn construction date is unknown. Original building

drawings were not available. The roof framing could be viewed from below and appeared in fair condition. It seems that several of the “knee” braces that were on the original roof trusses have been removed. This could limit the snow load carrying capacity of the roof trusses and lead to structural damage. The roofing appears to be in good condition from a distance view.
